INVESTIGATIONS ON AN 8-PATH ULTRASONIC METER – WHAT SENSITIVITY TO UPSTREAM DISTURBANCES REMAIN?

MR. JOHN LANSING, SICK | Maihak, Houston, Texas
DR. VOLKER HERRMANN, SICK | Maihak, Dresden, Germany
MR. TORALF DIETZ, SICK | Maihak, Dresden, Germany
MR. STEVE CALDWELL, CEESI, Nunn, Colorado

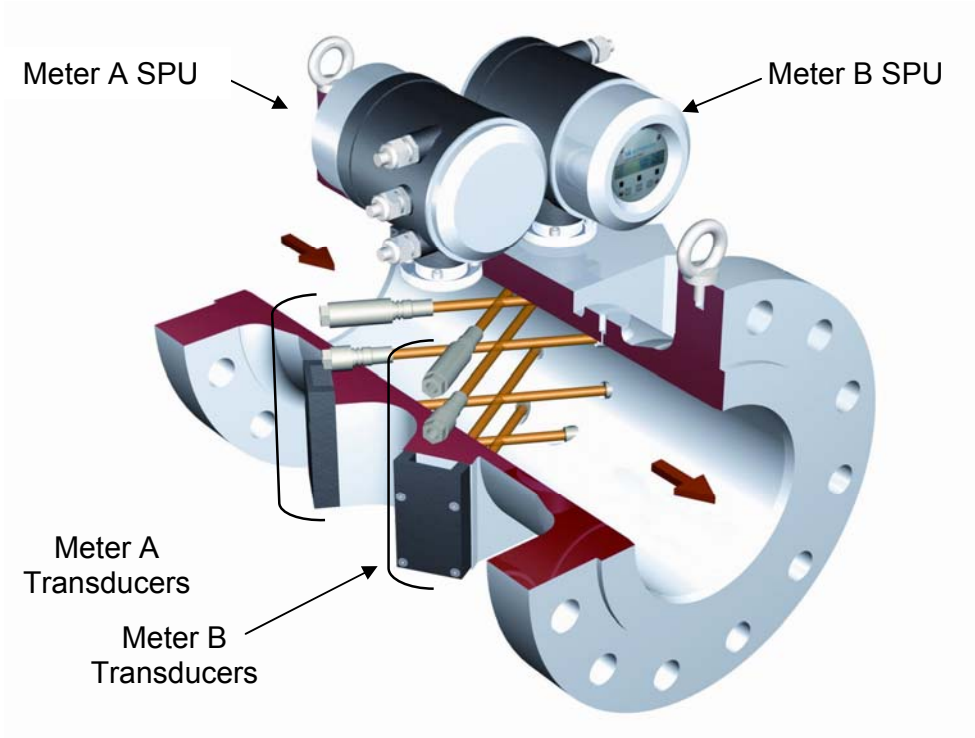
Figure 1: 8-Path Meter Used for Testing

Figure 1 is an artist drawing of this design. Two independent Signal Processing Units (SPU) were used, one for each diagonal of the X design configuration. For this paper Meter Electronics A will refer to the electronics associated with one 4-pair group of transducers, and Meter Electronics B will be associated with the second 4-pair group of transducers.

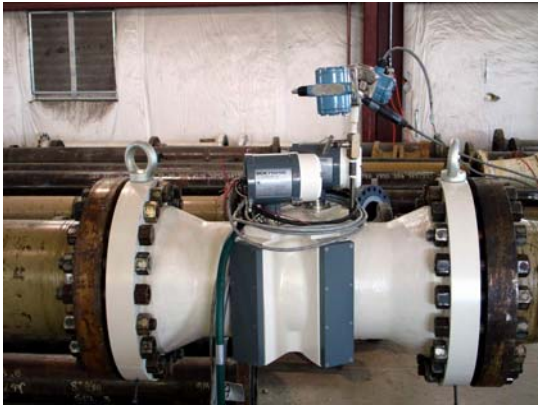
Figure 2: 8-Path Meter – Body

Figure 2 is a picture of the 8-Path meter installed in baseline piping. Note the two sets of electronics installed on the top of the meter. Two pressure transmitters were used to help reduce uncertainty. Figure 3 shows the inside of the meter body. All transducers are visible, and from this picture we can see the orientation is symmetrical from top to bottom, and also from Meter A to Meter B. In this design there are no bouncing signals, only direct line-of-sight communication between the sensors.

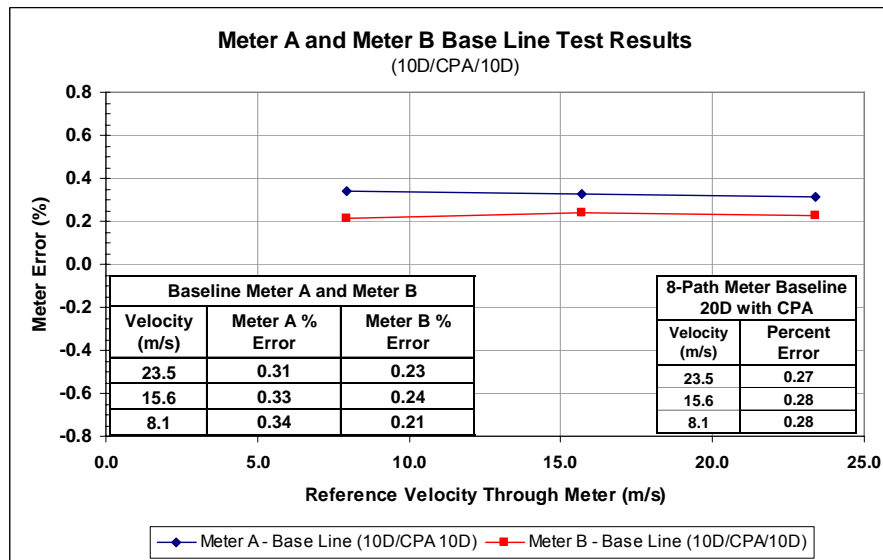
Figure 5: Baseline Test Results

Figure 5 shows the baseline results of both electronics under ideal conditions. The results show that both meter electronics (and associated transducers) were within about 0.15% of each other under ideal profile conditions. The average 8-Path unadjusted error was 0.28% as shown in the table within Figure 5. The 8-path errors were computed by averaging the results of each of the meter electronics.

This meter was also tested by the manufacturer at atmospheric conditions. The FWME results of the "as found" tests were within 0.1% of that shown in Figure 5. However, the meter was not adjusted by the manufacturer. The initial testing was to help validate the atmospheric test would agree with the high pressure calibration work performed by CEESI.

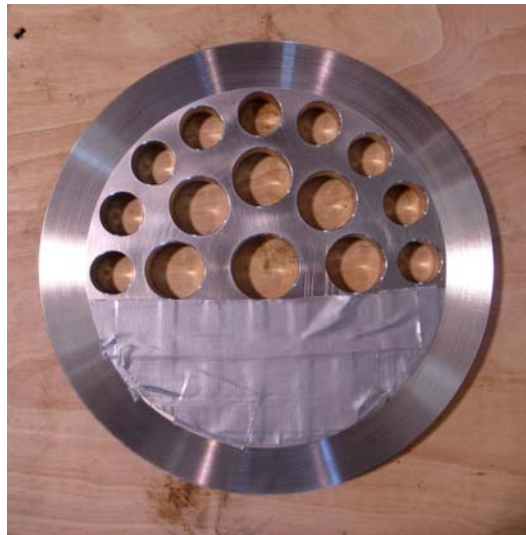
Figure 6: Blocked Flow Conditioner Used for Test

Users have often asked questions about the impact on accuracy of such blockage of the flow conditioner. With little data published, a test was conducted in 2004 and published at the CEESI USM Conference [Ref 4] and also at the 2005 NSFMW Conference [Ref 5]. To assess the impact of a significant obstruction in front of the flow conditioner, the previous test condition was duplicated (simulating a potential field type of blockage) by placing duct tape over approximately 40% of the flow conditioner. Figure 6 shows the blocked flow conditioner prior to testing. The blockage was installed at the bottom of the pipe.

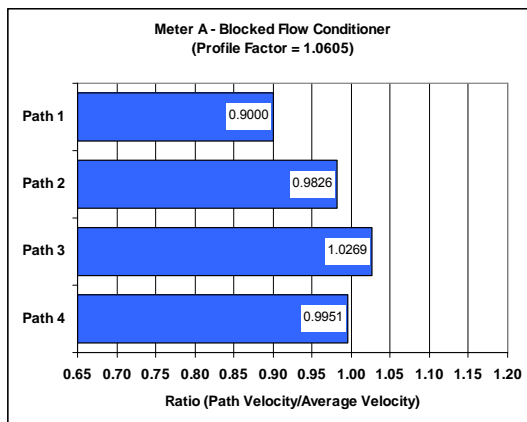
Figure 7: Meter A – Velocity Ratios with Blocked Flow Conditioner

This type of a blockage creates a distorted profile with little or no swirl. This effect can be seen in the velocity ratios of the 4 paths on Meters A and B shown in Figure 7 and 8. As can be seen the profile is shifted towards the bottom of the meter. This is due to the gas being pulled into the low pressure zone created by the blockage on the lower portion of the flow conditioner.

As is shown in the table within Figure 10, the impact on this blockage is on the order of -0.13%. Therefore, the distorted profile, as show in Figures 7 & 8, had little impact on the meter's accuracy.

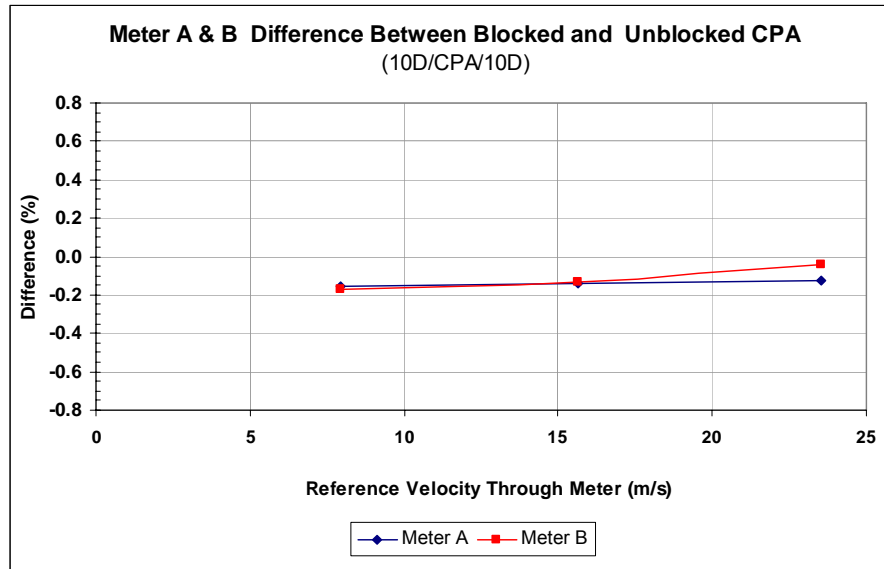
Figure 9: Meter Error – Blocked Conditioner vs. Baseline

Although the profile is quite distorted, the impact on the meter accuracy is minimal, as shown in Figure 9. Over the range of velocities tested, each of the meters shifted by less than 0.2%.

Figure 9 shows the results of each set of electronics (Meter A and Meter B). This graph represents the difference between the baseline (unblocked) and the blocked CPA for each of the individual electronics. To assess the true impact of an 8-path meter, both results (baseline and blockage) were externally averaged to produce a graph which represents the net impact on all 8 paths. Graphical results of this are shown in Figure 10 along with a table summarizing the percent difference between the baseline 8-path meter data and the blocked CPA flow conditioner data.

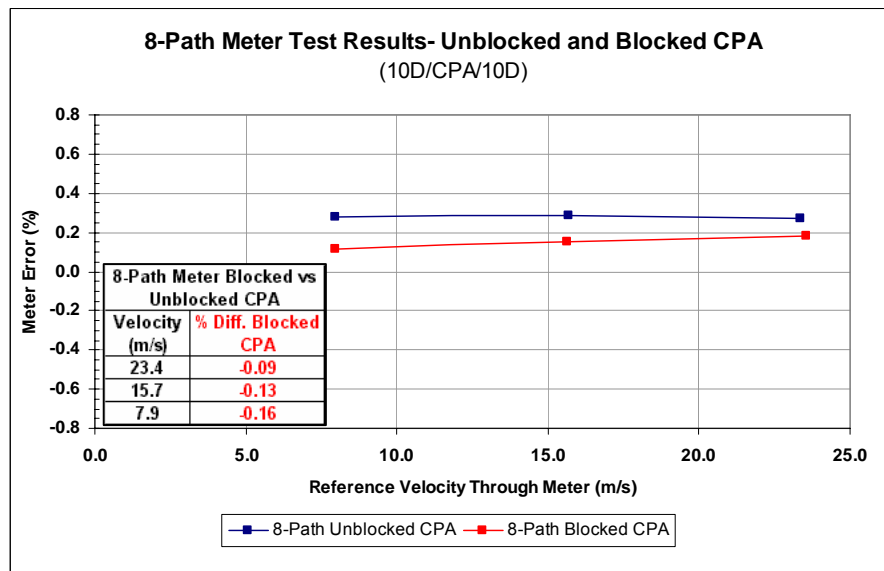
Figure 10: Meter Error – 8-Path Results

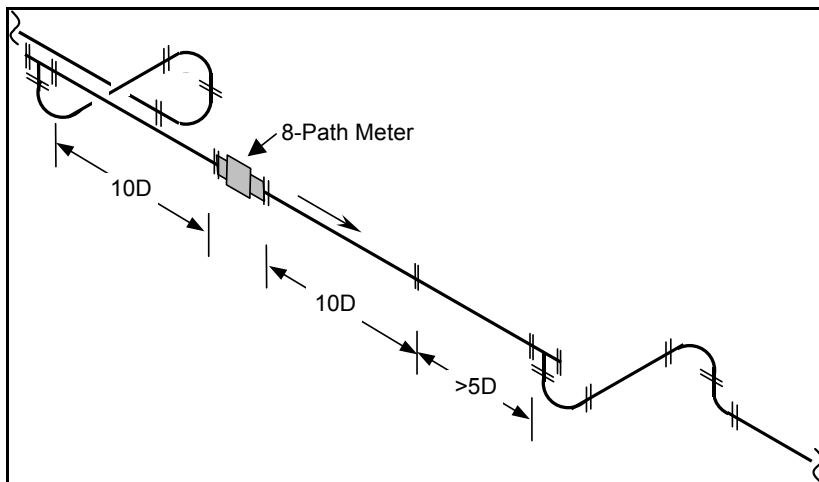
Figure 14: 10D – No Flow Conditioner Test Run Assembly

The next test was to move the meter from 20D to 10D downstream of the tee. Again this testing was performed with no flow conditioner. Figure 26 is a picture that shows this installation with the meter at 10D (also see drawing in Figure 14). In this picture the meter is located upside down. Later in the paper this will be discussed in further detail. The initial testing was performed with the electronics located upward.

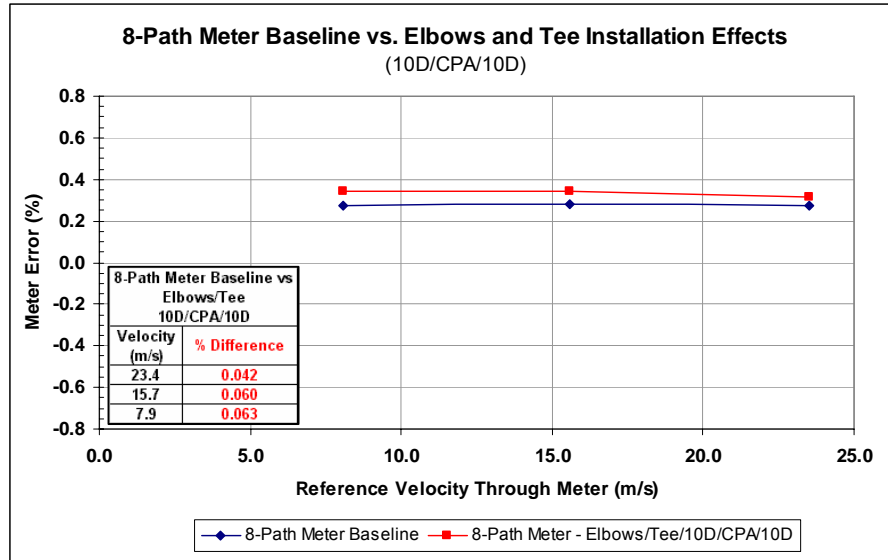
Figure 20: 8-Path Meter Performance with Tee and Elbows, 10D/CPA/10D

Figure 20 represents the performance of the 8-path meter baseline compared to the installation effect with the tee and elbow combination (10D/CPA/10D) as shown in Figures 12 & 15. The table with Figure 20 summarizes the differences which work out to an average of about 0.055%.

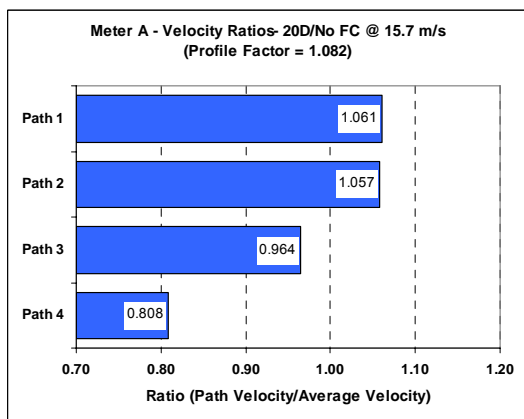
Figure 21: Meter A Profile for 20D – No CPA

The next test conducted was with the same 20D of upstream piping in front of the meter, as shown in Figure 13, but with this time there was no CPA flow conditioner. The velocity ratios, as shown in Figure 21 and 22, indicate a significantly distorted profile due to the meter now seeing the effects of the high amount of swirl caused by the upstream piping.

Due to the swirl, and the fact that the paths for Meter A are diagonally opposite to those of Meter B, the path velocity ratios are almost the inverse of each other.

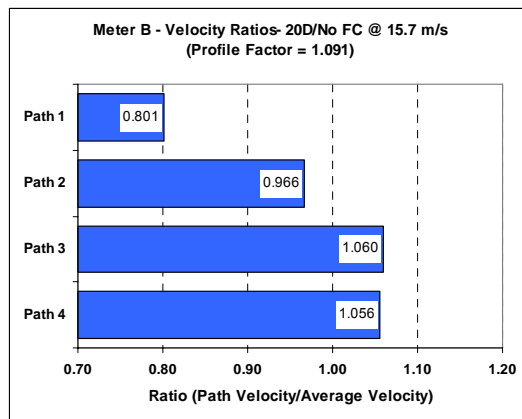
Figure 22: Meter B Profile for 20D – No CPA

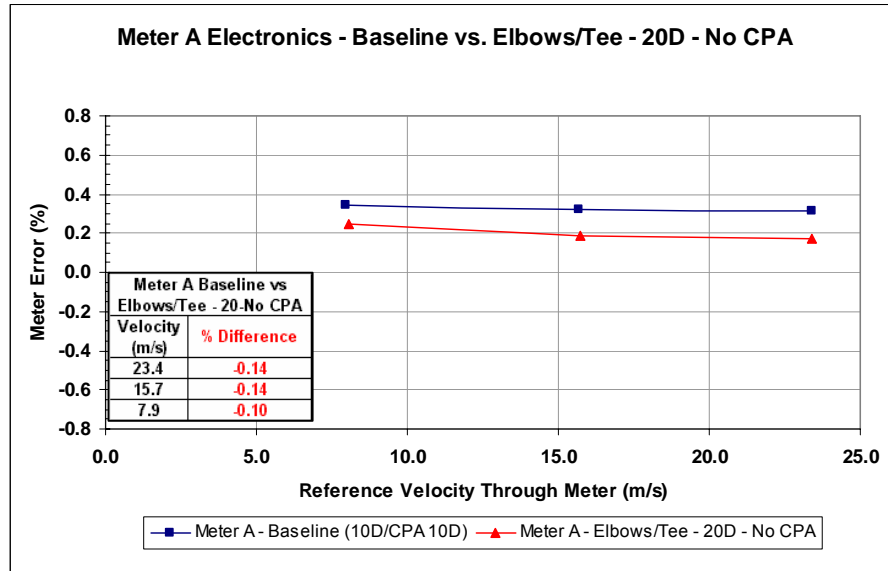
Figure 23: Meter A Results – 20D No CPA

Figure 23 shows the impact on the accuracy of the Meter A electronics and Figure 24 show the results for Meter B. Here we see that both electronics registered slightly slower than the baseline (somewhere on average around -0.15 to -0.2%). Both shifted in the same direction (slightly slower compared to the baseline).

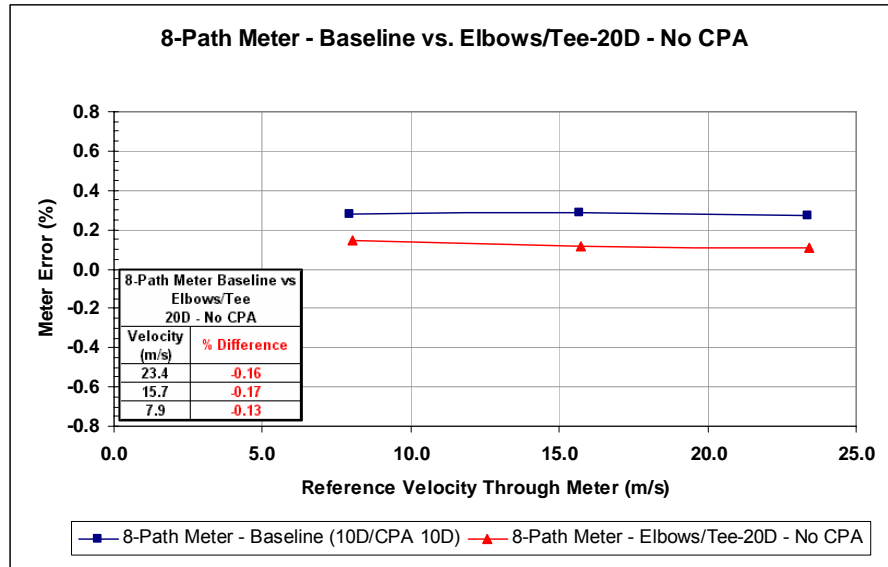
Figure 25: 8-path Meter Results – 20D No CPA

Figure 25 shows the results of the 8-path when both are averaged together. Since the bias for both Meter A and Meter B were similar, the net result is not much different than for the individual meter electronics. The inserted table shows the net affect to be on the order of -0.15%.

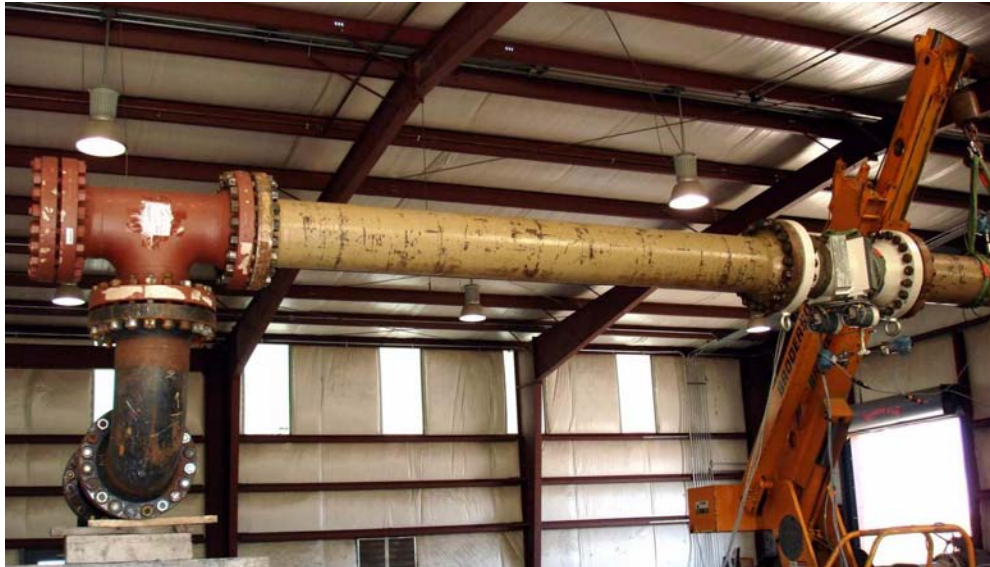
Figure 26: 8-path Meter at 10D No Flow Conditioner

To further investigate why Meter A's response was close to baseline, but Meter B's was more affected, additional testing was performed at the CEESI Calibration Facility approximately 2 months later (September 2006). The photo in Figure 26 was taken during the time of the additional testing.

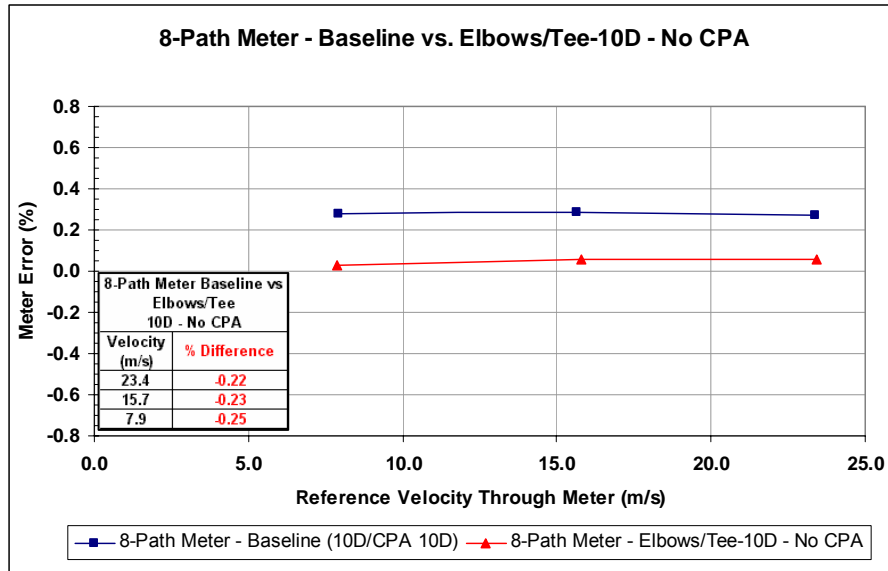
Figure 29: 8-Path Meter at 10D No Flow Conditioner

The following three figures show the results of Meter A, Meter B and the 8-Path meter results from installation at 10D and no flow conditioner. The 8-Path results were the average of each of the meter's results.

In reviewing the results of both Meter A and Meter B results, it is apparent that there is a more significant difference than was shown at 20D with no flow conditioner. Meter A was relatively unaffected where Meter B exhibited more affect. Averaging the two to produce the 8-Path results shows that the impact on accuracy is only on the order of -0.23% on average.

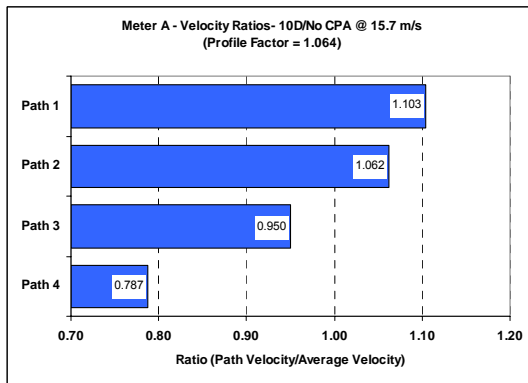
Figure 30: Meter A Profile at 10D – No CPA

Figures 30 and 31 show the distorted velocity profiles produced by this combination of elbows and tee. Once again we see an extremely distorted profile, with Meter B being virtually the inverse of Meter A. This is due the significant amount of swirl which is caused by the series of elbows and the tee being out of plane.

By reviewing the profiles at 20D and 10D with no flow conditioner, it is apparent the distortion caused by the swirl in the pipeline has increased. The difference between Path 1 and 4, when the meter was located in the 20D configuration, showed approximately 26% difference in velocity. At 10D the difference increased to about 32%, indicating significantly more swirl. The important thing to remember is the profile shown in Figure 30 and 31 is what the CPA flow conditioner was presented with. The profile after the CPA, as seen by the meter 10D downstream, had very little distortion. This can be seen by comparing Figures 30 and 31 with Figures 18 and 19.

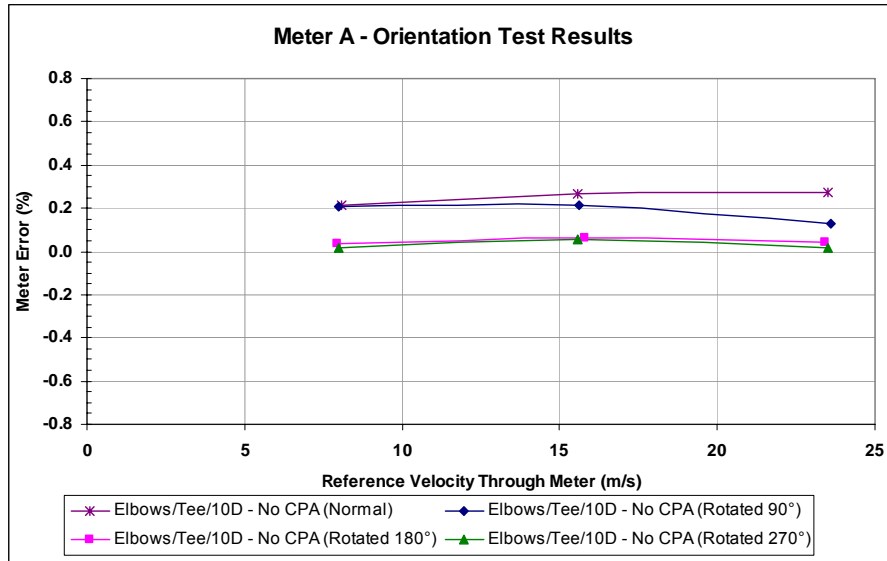
Figure 34: Meter A Error As a Function of Radial Orientation

Figures 34 and 35 represent error curves for each of the meter electronics. The net shift from the severely distorted profile was on the order of -0.2% from baseline. This installation created much more severe profile distortion and swirl than a typical piping installation. Thus one would expect the performance of the 8-path meter in a typical field installation to be better than this.

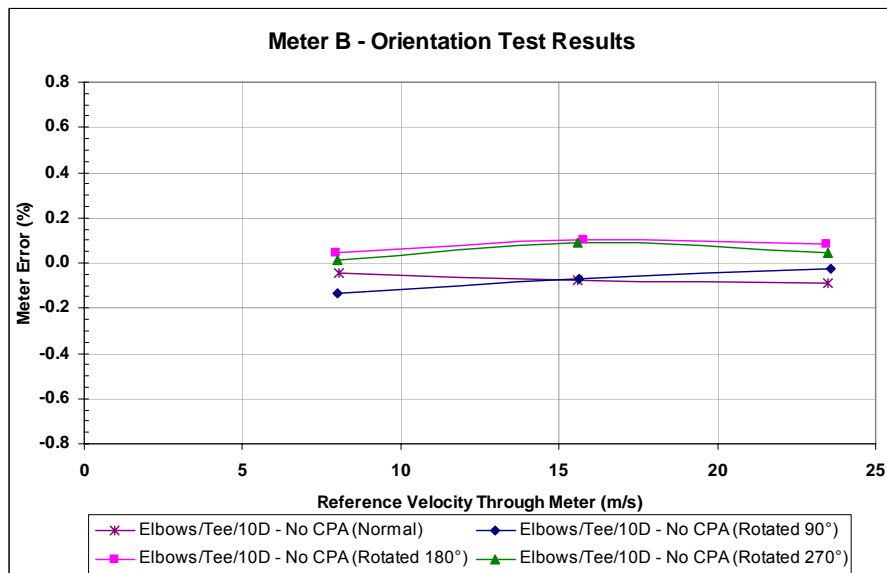
Figure 35: Meter B Error As a Function of Radial Orientation

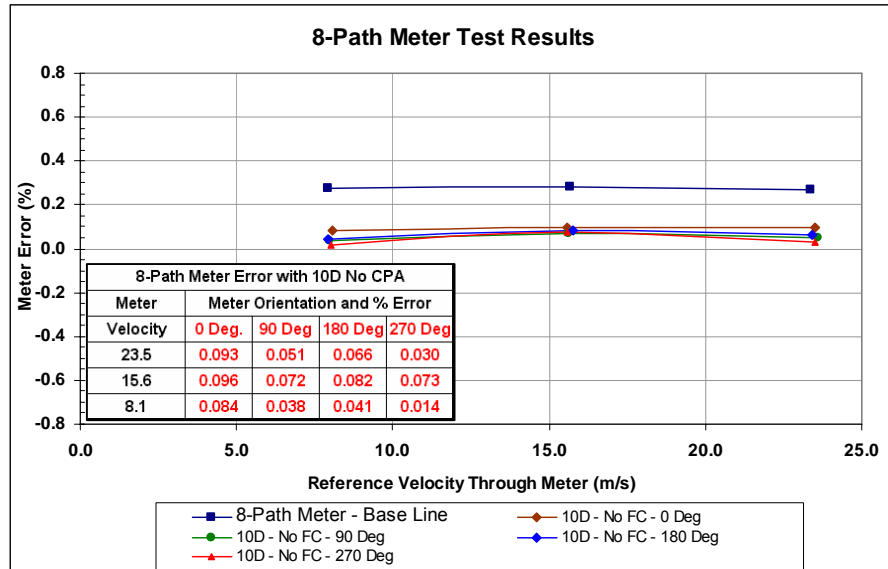
Figure 36: 8-Path Meter Error As a Function of Radial Orientation

These results show two distinct performance results depending upon orientation. These results were combined to produce the results of the 8-path meter and are shown in Figure 36.

Figure 36 shows the baseline error of the 8-path meter, and then the meter error for each of the individual 8-path meter orientations. From these graphs it can be seen that for both meters the deviation did not change by more than about 0.04% due to the radial orientation of the meter. This would be considered scatter and is not a significant.

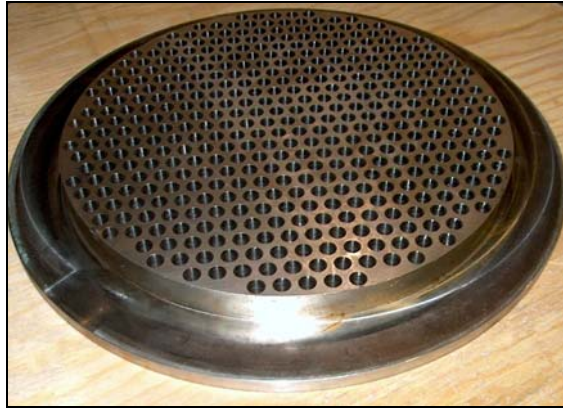
Figure 38: PTB Flow Conditioner

One solution is to use a PTB flow conditioner which is located 2D from the meter, and with 3D upstream, for a total installed upstream length of only 5D. This flow conditioner has 421 small holes that permit installation much closer to a meter than traditional flow conditioners. Figure 38 is a picture of this device.

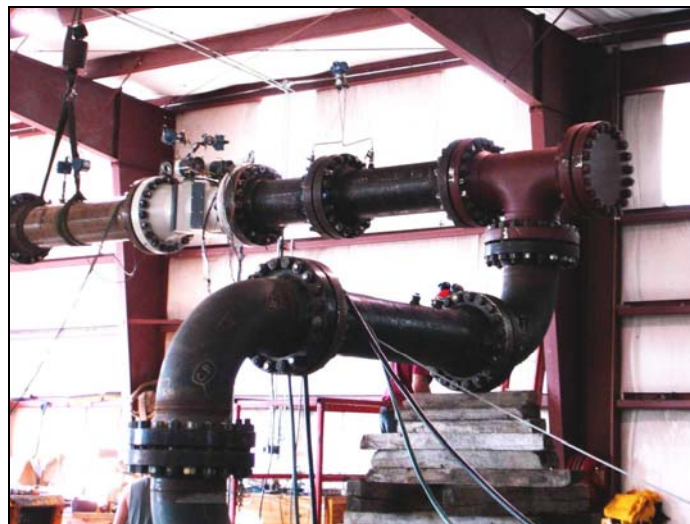
Figure 40: 8-Path Meter with PTB Flow Conditioner Piping

The PTB flow conditioner was also tested with the same elbow and tee combination discussed earlier in this paper. Figure 39 is a drawing of this flow conditioner at the time of testing. Figure 40 is a picture of the PTB taken at the time of testing.

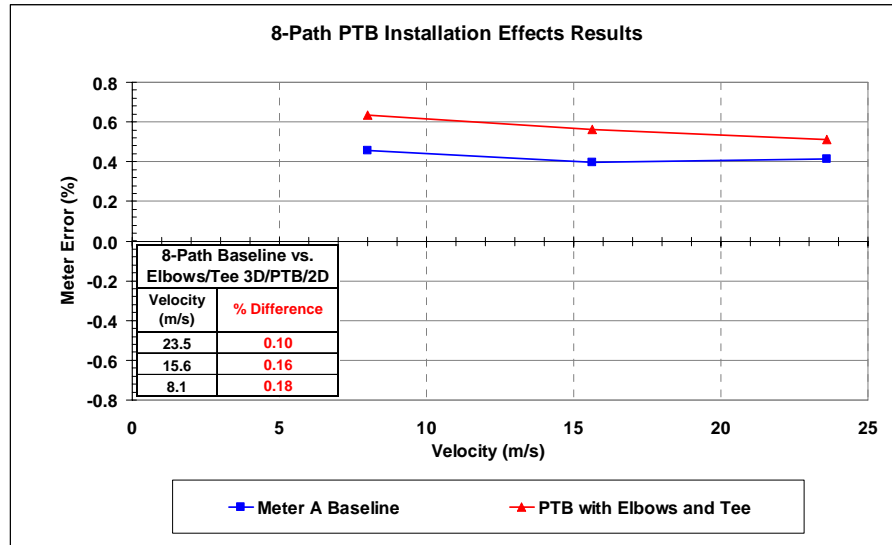
Figure 41: PTB Flow Conditioner Downstream of Elbows and Tee

The results of the baseline test with the PTB and the 8-path meter vs. the installation effects are presented in Figure 41.

Figure 41 shows the 8-path meter baseline with the PTB flow conditioner and with the elbows and tees. This shows the 8-path meter provides results that are well within the uncertainty budgets of PTB and ISO, and also well within AGA 9 requirements. The table within Figure 41 shows the installation affect was only on the order of +0.15%. For close coupled applications, where space does not permit installation of 10D of straight pipe, the PTB conditioner will provide results that are comparable to 10D with no flow conditioner. The penalty of using a flow conditioner is the added differential pressure and installation costs.
